Some More Modifications

30m QRSS beacon: QRV: more modifications

Written by Hans Summers

Monday, 25 May 2009 02:55 -

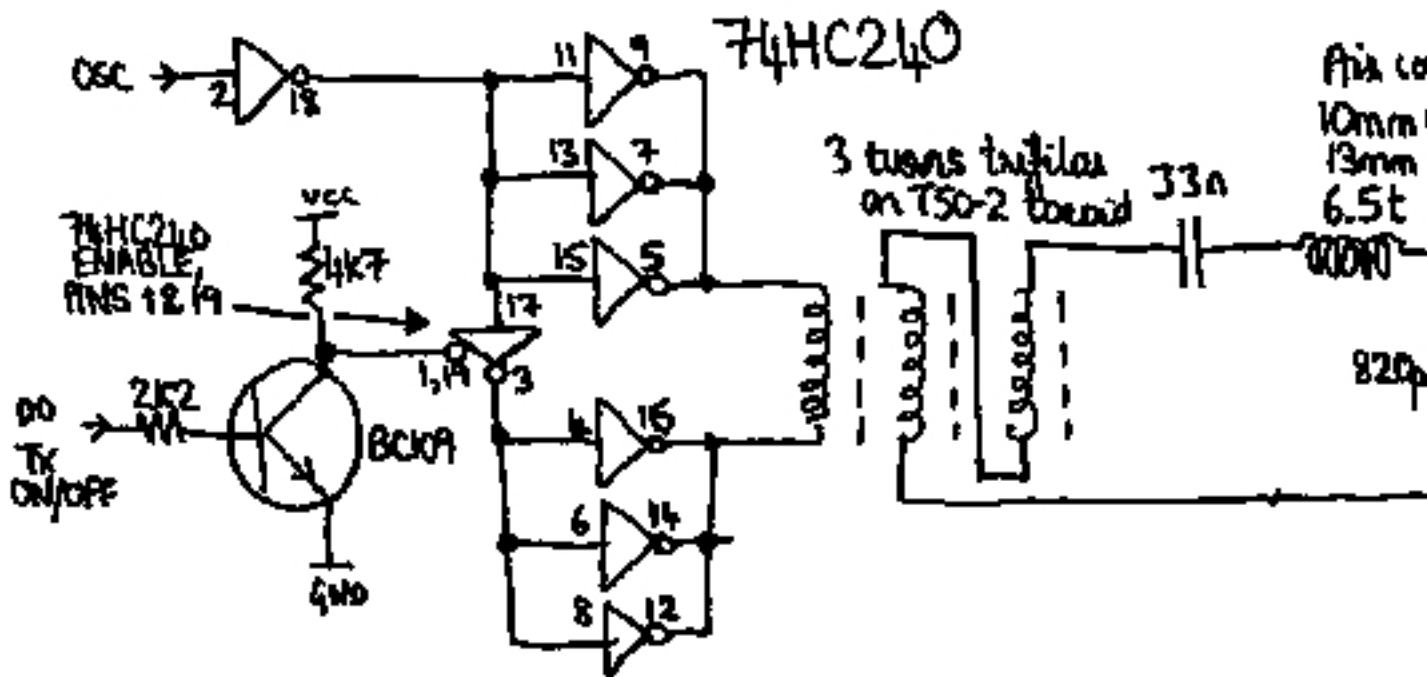
I suspect that the problem with chirp is caused by the single gate of the 74HC86 chip which is being used as oscillator, being connected directly to 74HC240 power amplifier. Any tiny change in capacitance or loading of the 74HC240 input (i.e. when it heats up) will be able to pull the crystal frequency and cause the observed chirp. So I made 3 further modifications (less major than the last batch):

This is the new circuit of the oscillator section, incorporating all the changes since the original design where the oscillator inverter was one of the gates on the 74HC240 (**loads** of chirp!).

First, I utilised the other 3 XOR gates in the 74HC86 as buffers, to isolate the oscillator inverter from the power amplifier. I can't actually think why I didn't do this in the first place, the gates aren't required for anything else.

Secondly, I increased the series resistor (by two 39K resistors in series with the existing 100K) in the frequency shift resistor network that controls the varicap (5mm red LED). This will make the shift voltage have less magnitude. I hope that the new range is approximately the same as it was originally prior to the installation of the 74LS08 buffers, and with the full linearity restored.

Finally, I have piled in a few more capacitors around the 5V voltage regulator which supplies the oscillator. I am a lifelong believer in the principle that you can **never** have too many capacitors in a power supply.
