CPCNG Notes: IDE interface

This page describes the proposed IDE hard disk interface. The IDE specification is simpler than SCSI so has been chosen for the prototype. The IDE interface would be almost trivial but for the fact that the IDE databus is 16 bits wide, whereas the eZ80 data bus is only 8 bits wide. It is possible to connect only 8 bits of the IDE bus directly to the eZ80 data bus, but doing this sacrifices half the capacity of the disk drive.

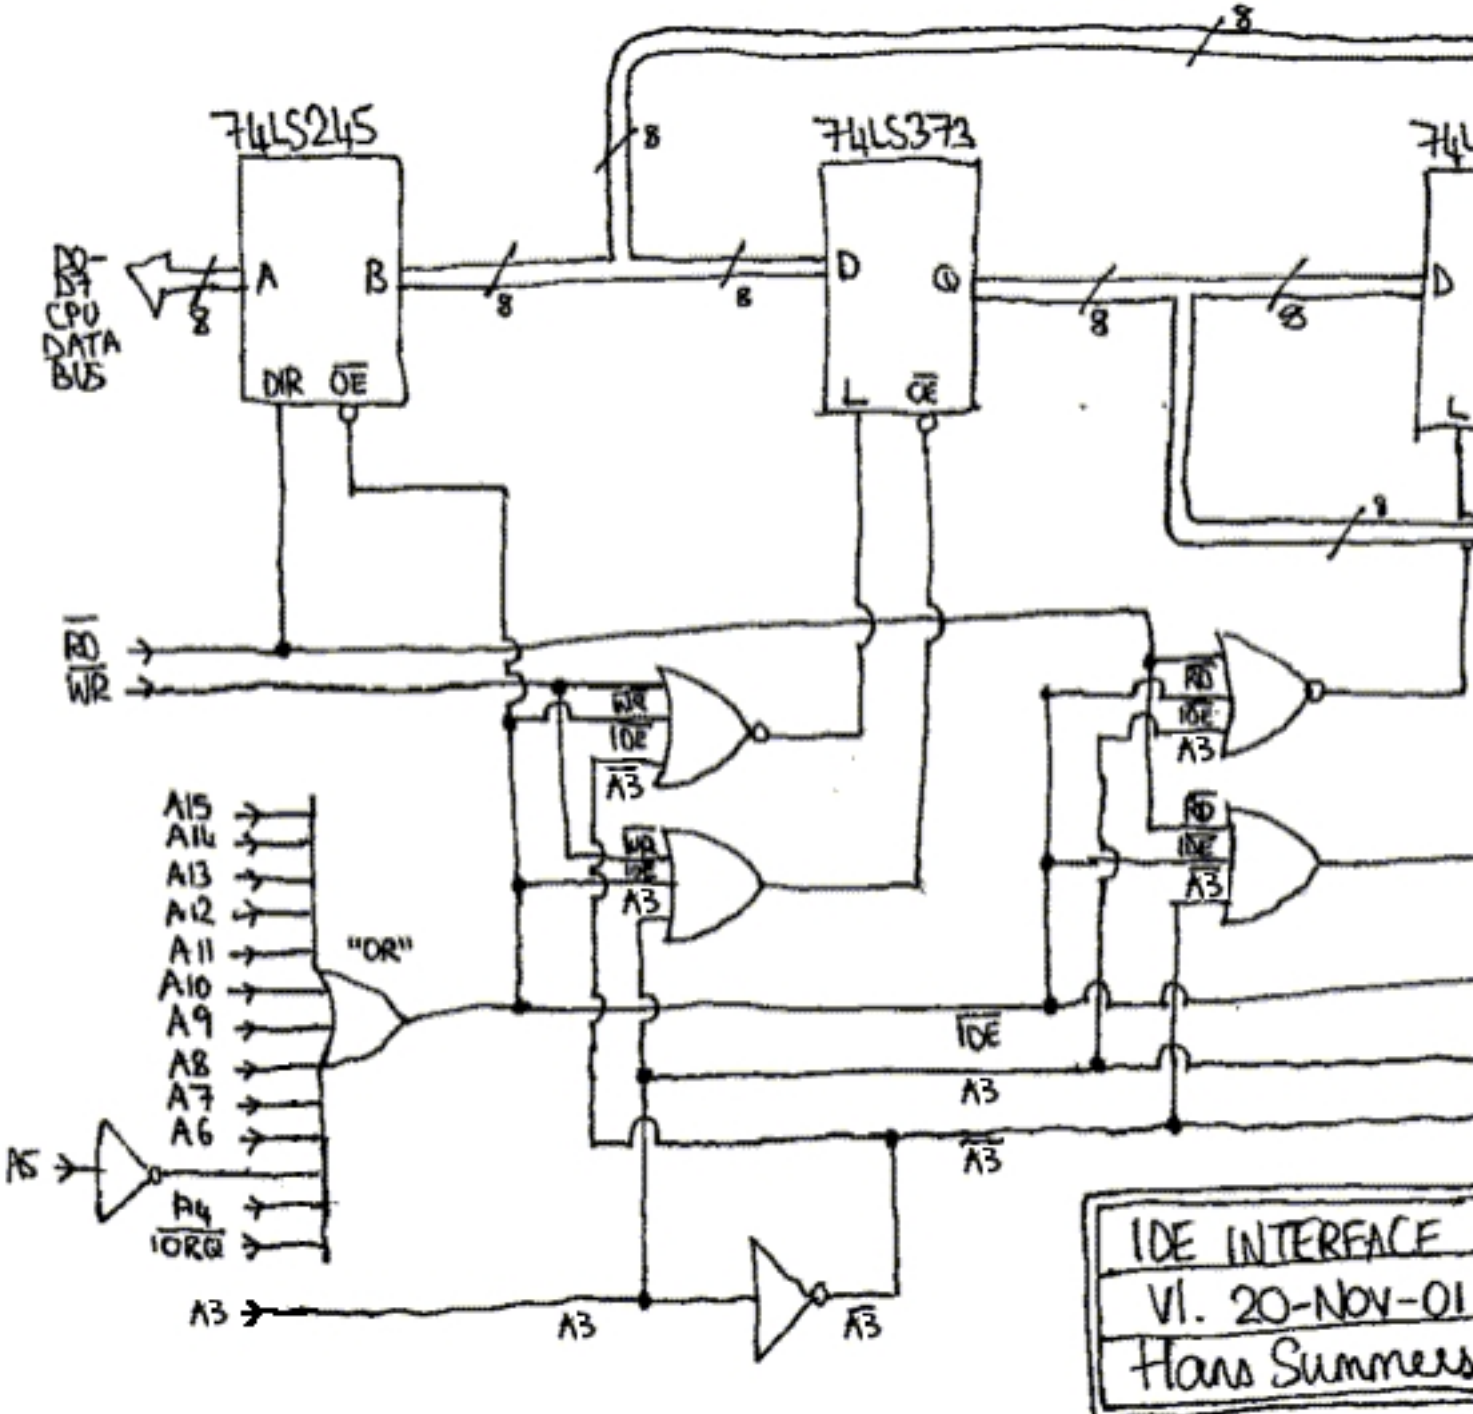
The solution here is to buffer the high byte of the data word in an 8-bit latch, which is read/written to on an additional port number. There are a number of examples of this on the internet, with circuit diagrams and sample code (see list of links below). The information and circuit described here are derived from these project pages. Below is the draft circuit diagram.

Figure 15: IDE interface circuit. © 2006-2007 Hans Summers. All rights reserved. Written by Hans Summers
CPC NG I/O Addresses for IDE Registers

The following table describes the port mapping of the IDE interface:

&0020	IDELO	Data Port (low byte)
&0021	IDEERR	Read: Error Register; Write: Precomp
&0022	IDESECTC	Sector Count
&0023	IDESECTN	Sector Number
&0024	IDECYLLO	Cylinder Low
&0025	IDECYLHI	Cylinder High
&0026	IDEHEAD	Drive/Head
&0027	IDESTTS	Read: Status; Write: Command
&0028	IDEHI	Data Port (High Byte)
&0029		
Not Used		
&002A		
Not Used		
&002B		
Not Used		
&002C		
Not Used

&002D		
Not Used		
&002E	IDECTRL	Read: Alternative Status; Write; Device Control
&002F	IDEADDR	Drive Address (Read Only)
